ENEWETAK FACT BOOK

(A RESUMÉ OF PRE-CLEANUP INFORMATION)

COMPILED BY
WAYNE BLISS
U.S. ENVIRONMENTAL PROTECTION AGENCY

COMPILED 1977
PUBLISHED SEPTEMBER 1982

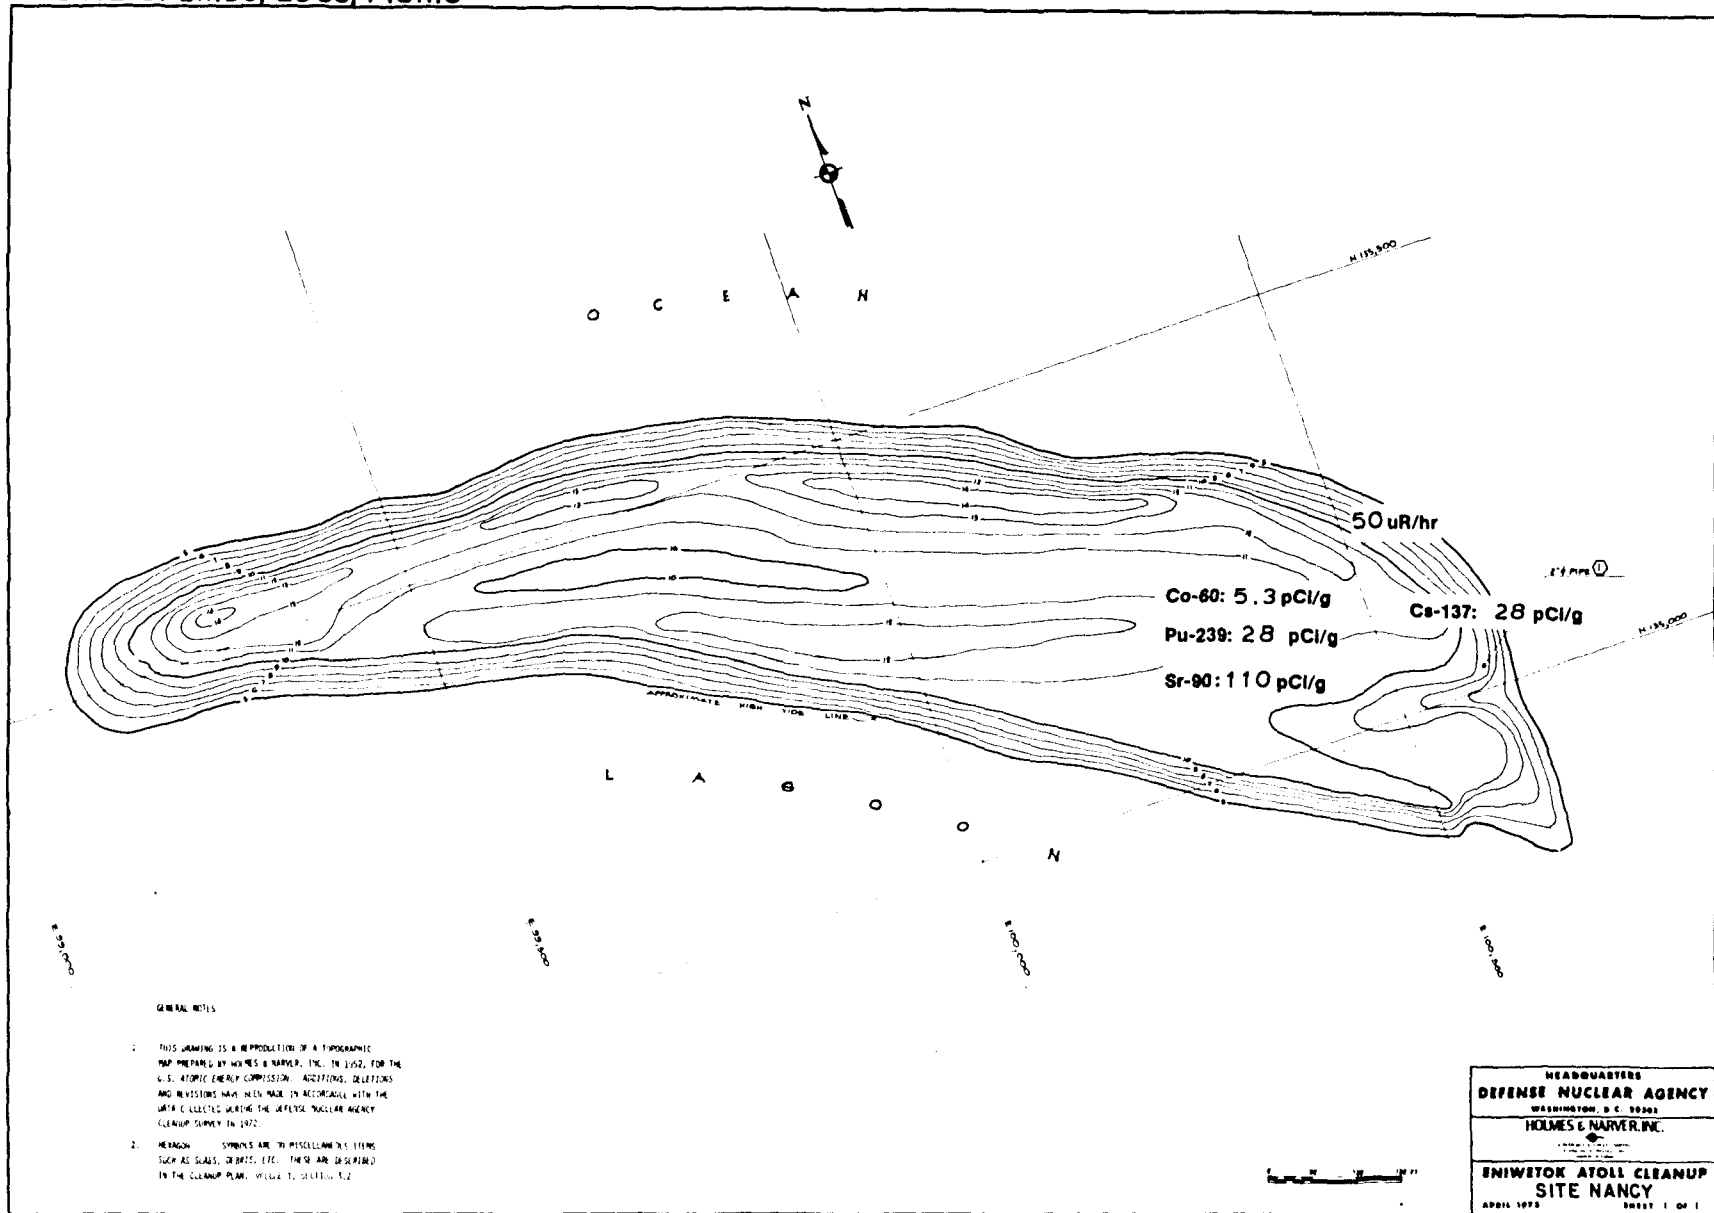
FIGURE 38. SITE NANCY

No radioactive material burial sites are known to exist on NANCY.

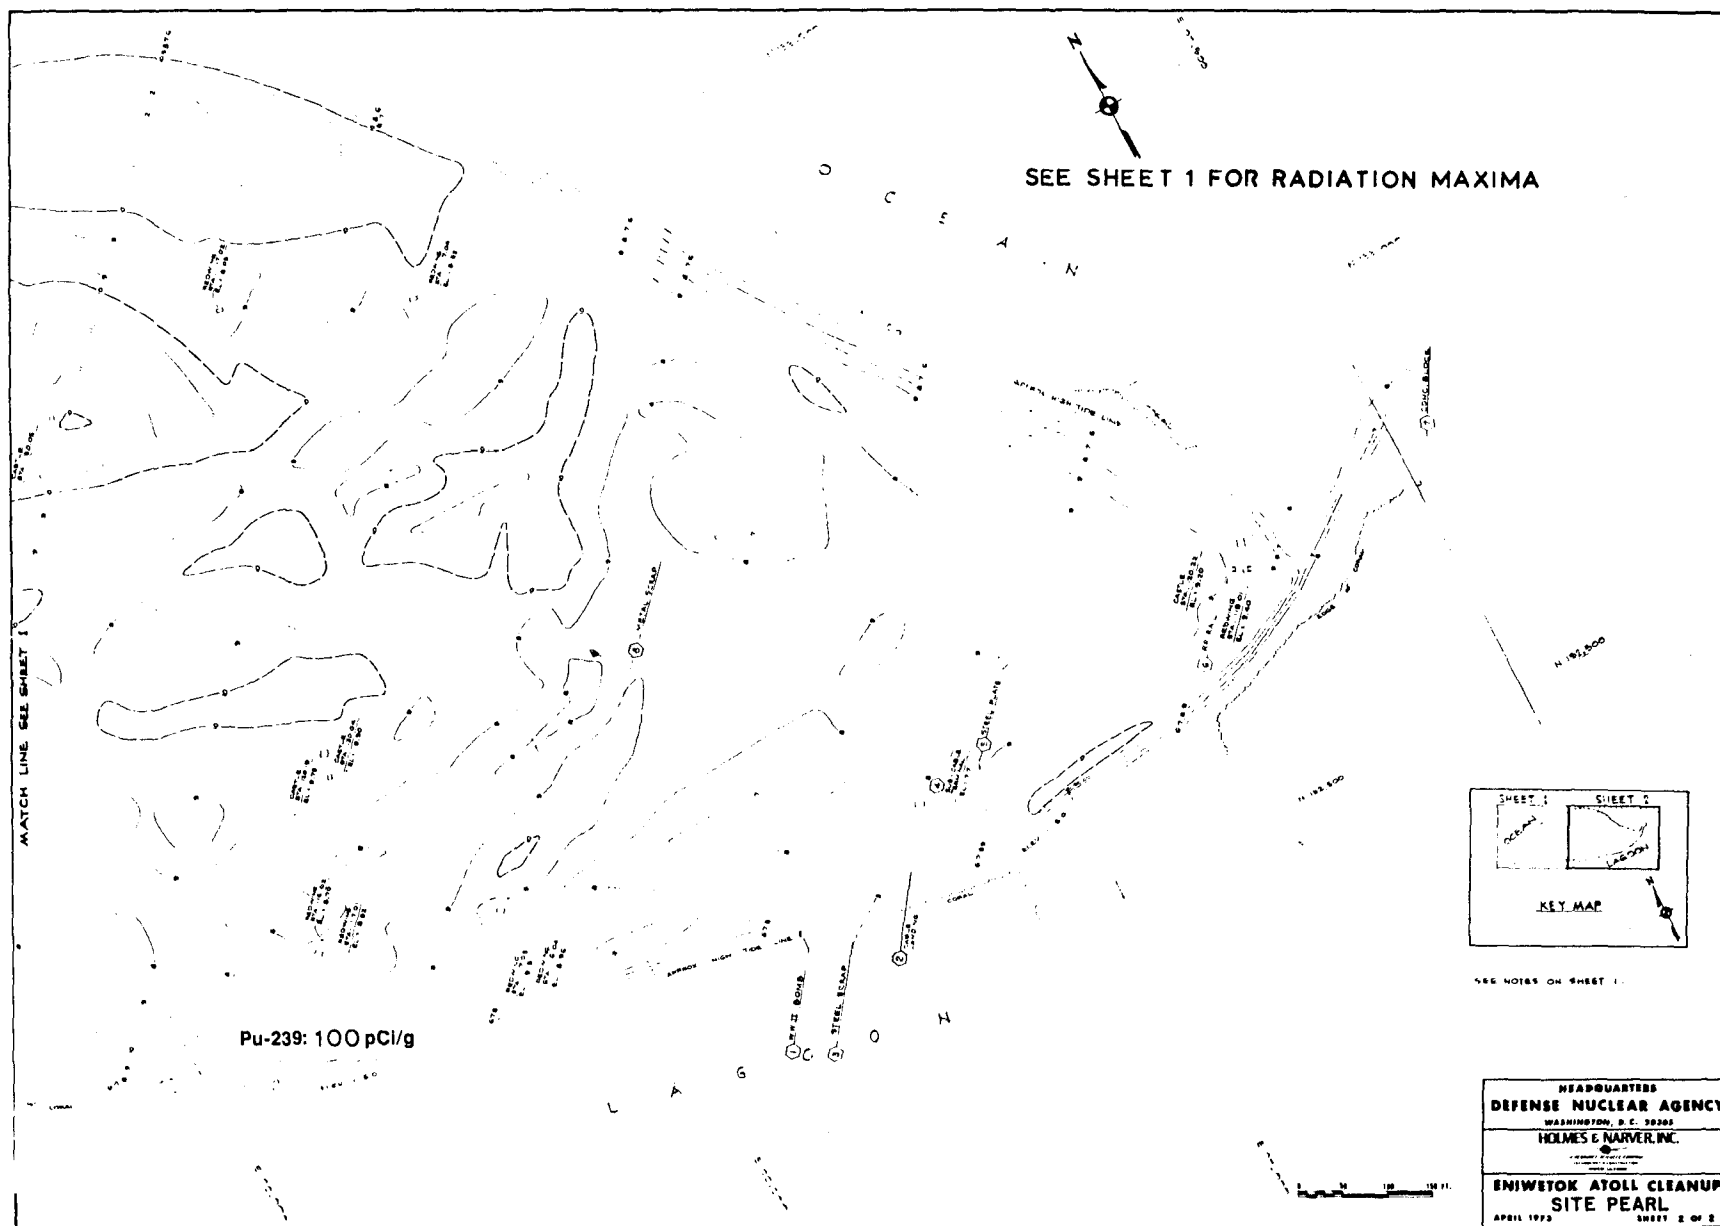
FIGURE 41. SITE PEARL, SHEET 2 OF 2

PEARL was the location of the INCA EVENT of OPERATION REDWING. PEARL ranks 6th of the islands in the Atoll with 4,329 R/h accumulated H+1 hour exposure rate. This exposure was the result of INCA plus 12 other shots. INCA was conducted on June 21, 1956, and produced heavy local contamination on the shot island, however, did not delay preparations for the MOHAWK EVENT on adjoining island RUBY. Four concrete anchor blocks are located on the northwest end (Figure 40) around the INCA ground zero. Some debris from testing is located toward the southeast end of the island (Figure 41).

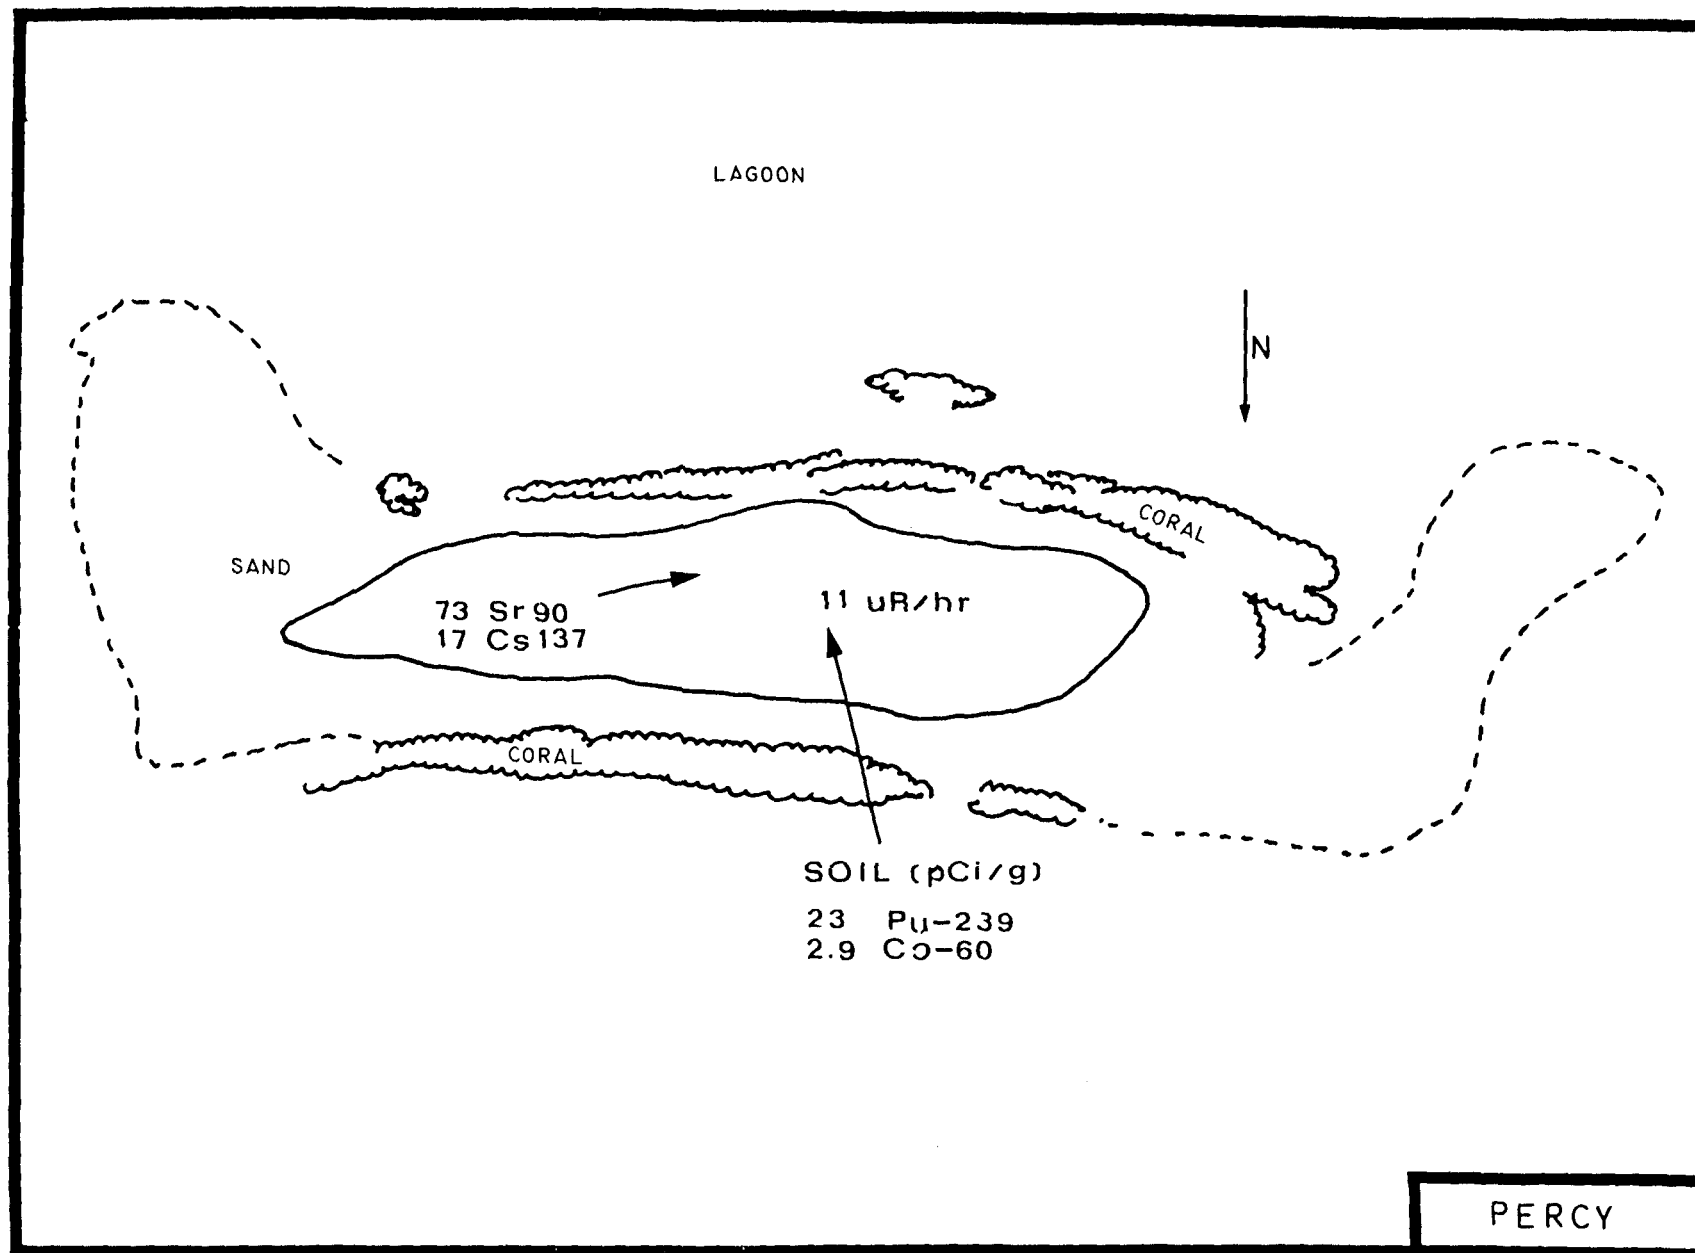
FIGURE 45. SITE PERCY

The depth distribution obtained from a single profile indicates that the maximum activity is situated 3-8 cm below the surface with a rapid decrease from 8-20 cm. Plutonium-239 was measured to be 90 pCi/g at 7.5 cm in depth.

No radioactive material burials are known to exist on PERCY.

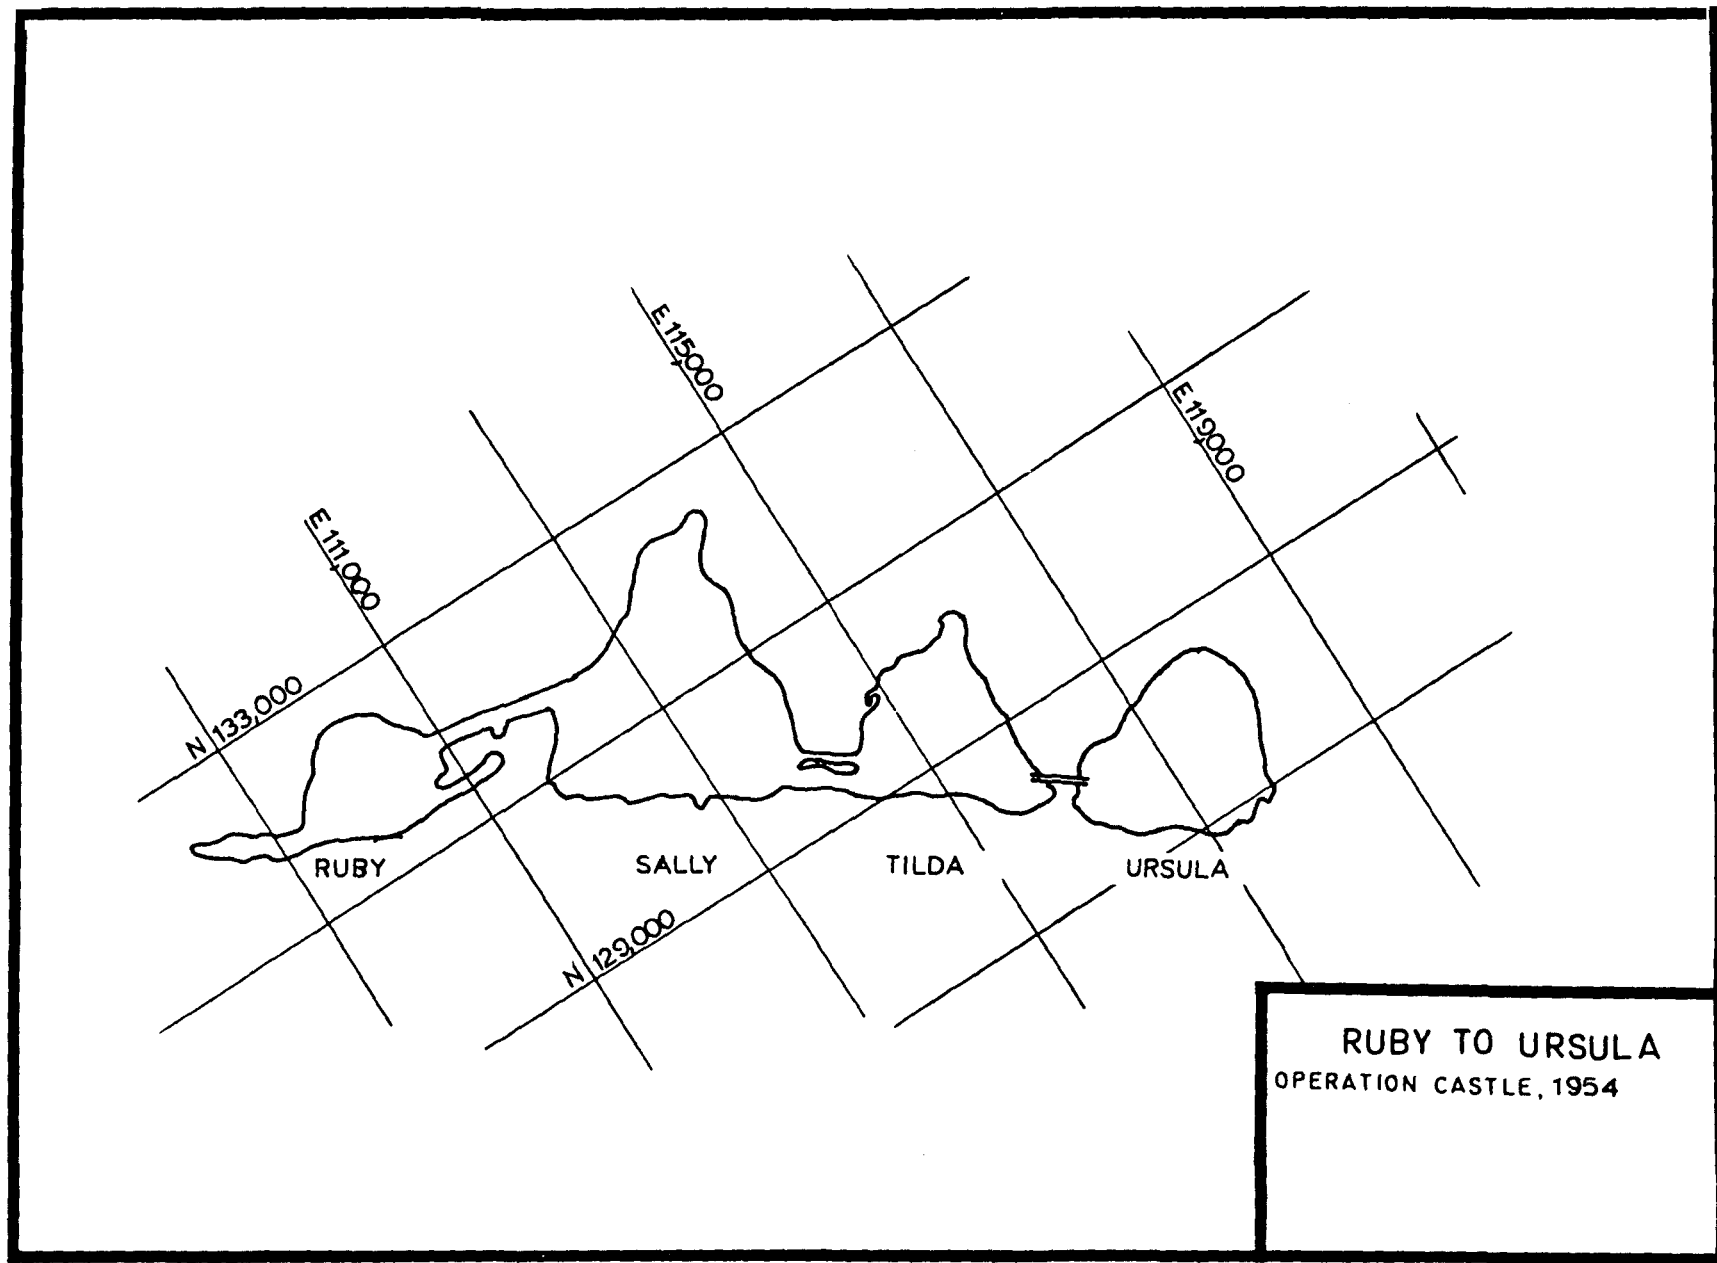
FIGURE 46. SITES RUBY TO URSULA

RUBY was an island located in the northeastern portion of Enewetak Atoll. The original island has been nearly destroyed as a result of nuclear testing. As a result two small islets exist. The islet farthest from Site SALLY was identified as RUBY in NVO-140 and the islet at the end of the north causeway from SALLY was included with SALLY. The Pacific Cratering Experiments (PACE) of early 1972 contributed to this misnaming perhaps by grading SALLY and filling the area (an old borrow area) south of the RUBY-SALLY causeway. Figure 46 shows the original land areas of RUBY and the SALLY-TILDA-URSULA complex.

Aerial photographs show some debris remains from testing and, although not so identified by NVO-140, may be contaminated. That report designates RUBY as a burial site because two zero points existed there. As water now covers these points, burial should not be assumed in the general sense; however, a shallow water survey may reveal debris which may be contaminated.

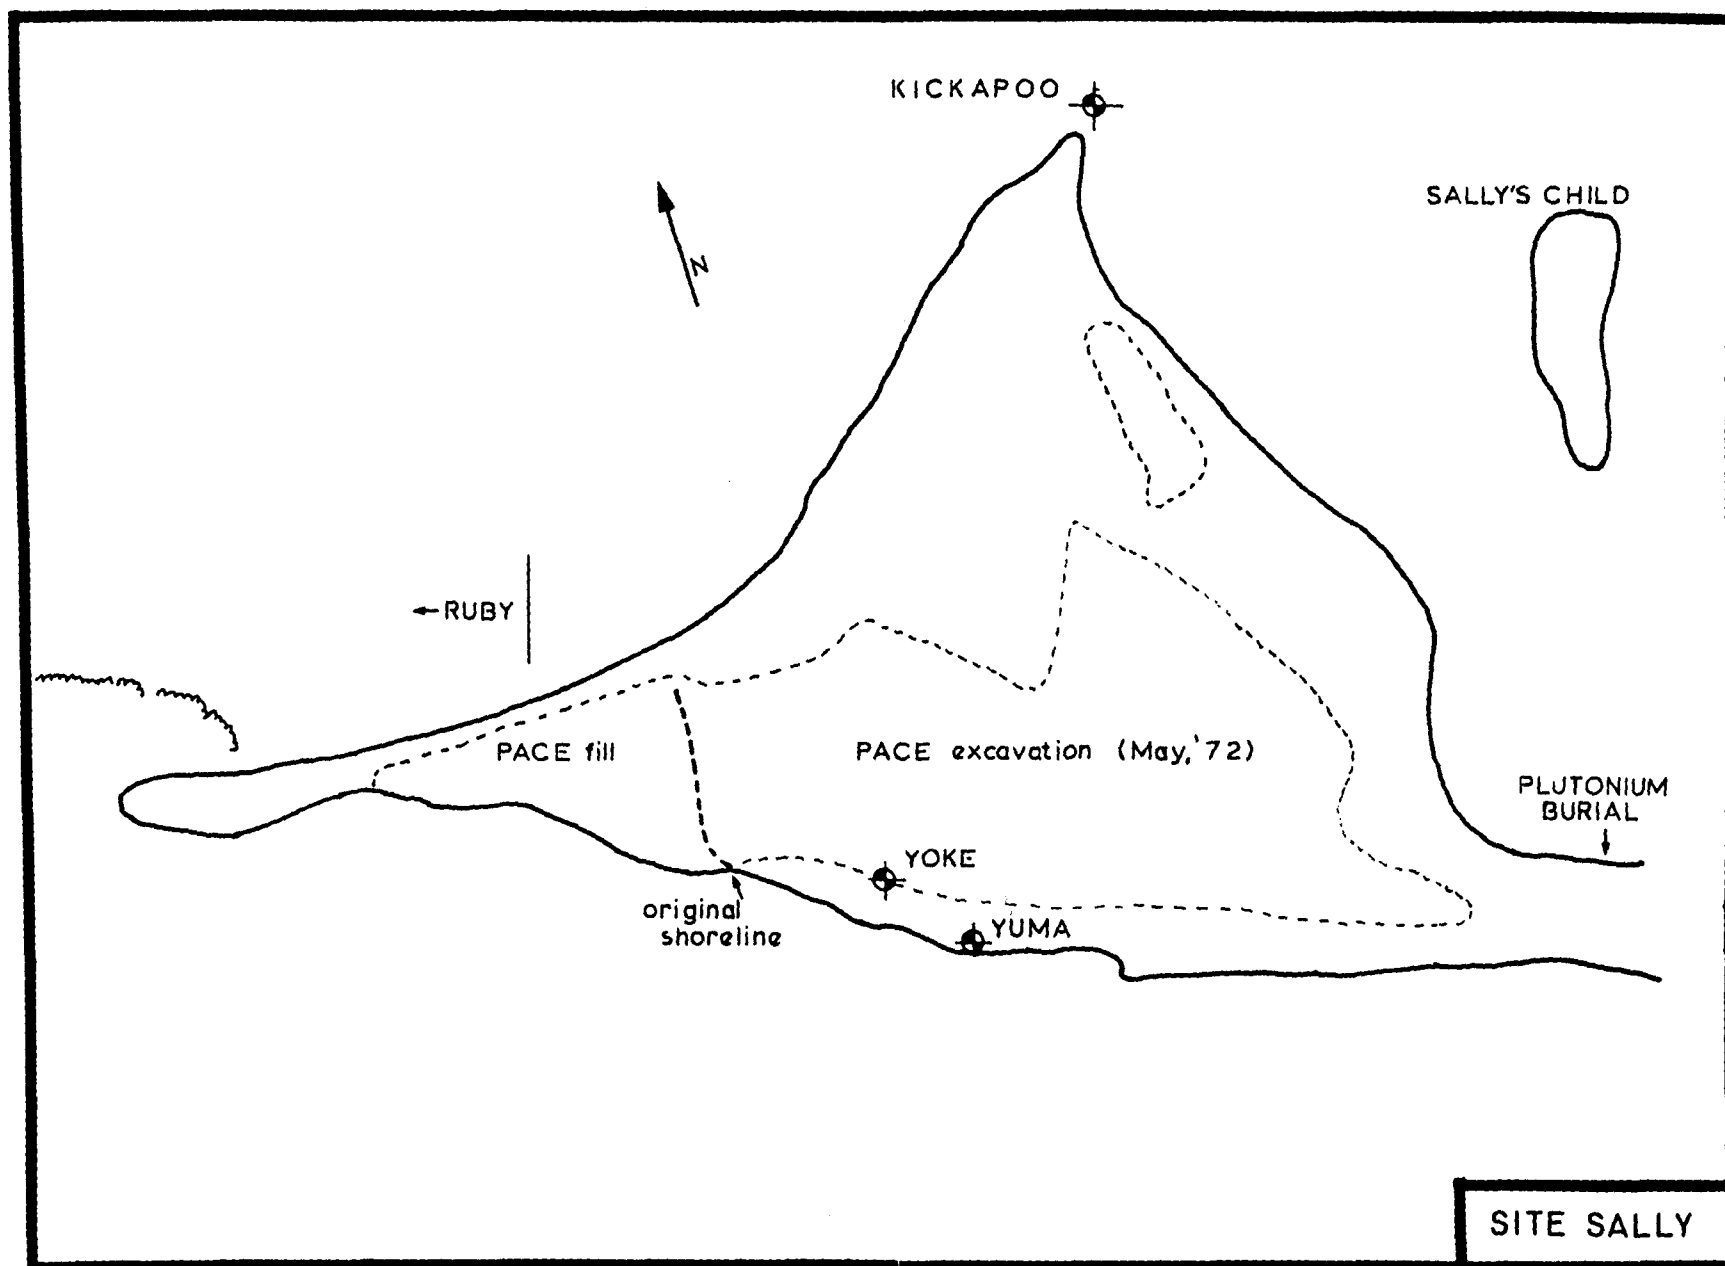
FIGURE 50. SITE SALLY, PRINCIPAL FEATURES

SALLY was used for various types of instrumentation during other nuclear operations. It was also one of the sites used for the Pacific Cratering Experiments (PACE) Program in 1972 as evidenced by the defoliated areas and small craters present. This excavation undoubtedly altered the radiological conditions on SALLY; however, these activities were concluded prior to the radiological survey reported in NVO-140. As a result of the PACE, the topographic drawings used here do not show the appropriate roads, etc. for a large section of the island, nor do the drawings show the area filled between RUBY and SALLY west of the causeway. From the 1972 aerial photo in NVO-140, this area was apparently filled to a height greater than high water line and now has an established beach. Soil movement was approximately as outlined in Figure 50.

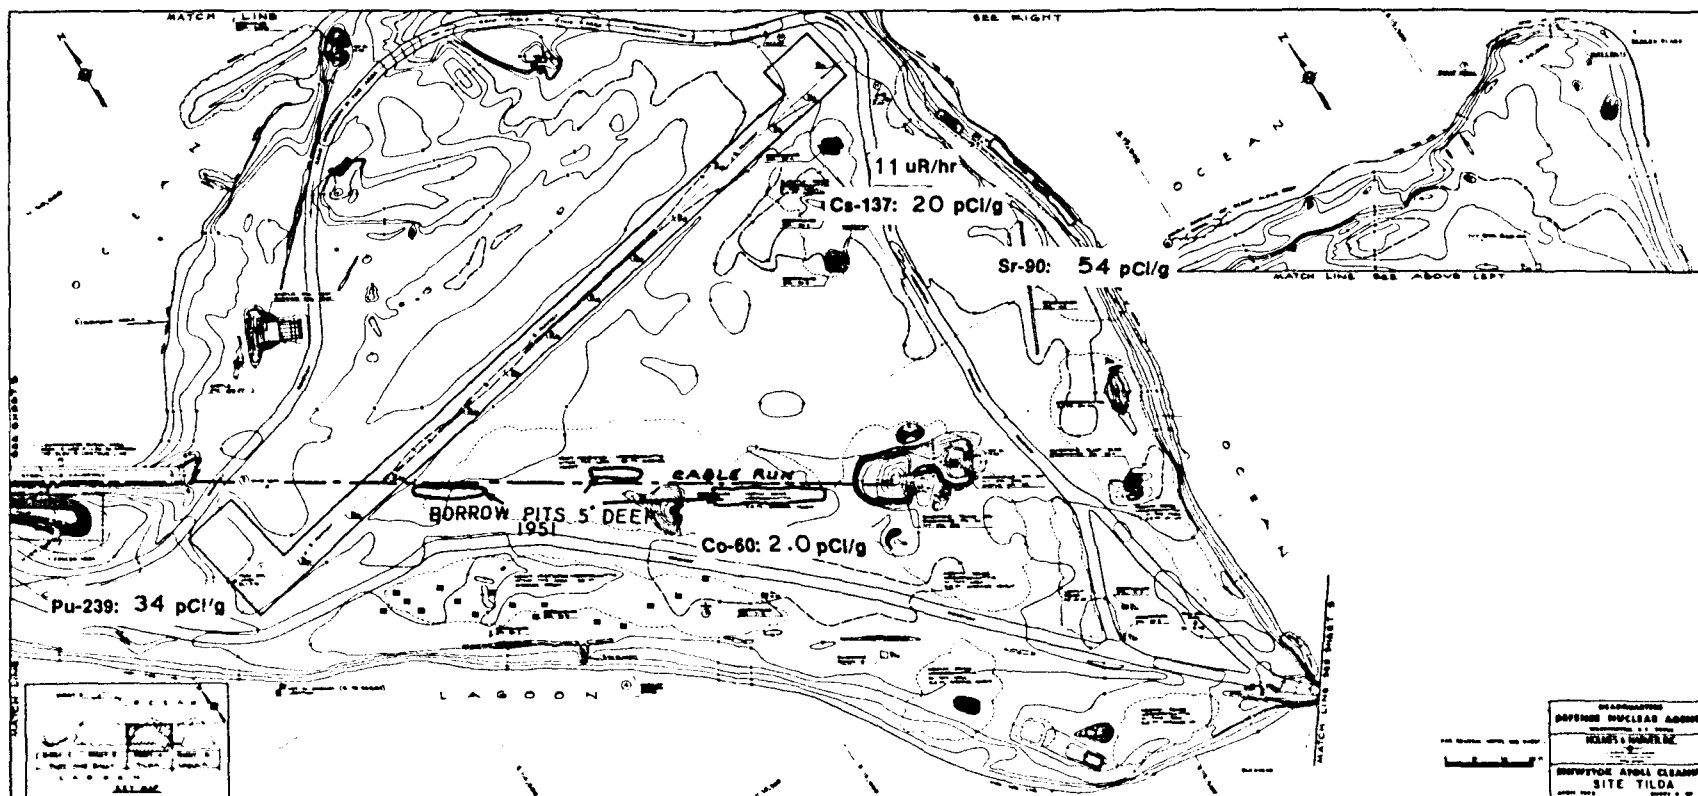
FIGURE 60. SITE TILDA

No radioactive material burial sites are known to exist on TILDA. An alpha disposal site exists between the manmade and natural causeways which connect TILDA to SALLY. That site is described in the previous report for Site SALLY. Considerable construction activity has occurred on TILDA which may have caused burial, mechanical or natural, or low level contamination, e.g., coaxial cable burials and the erosion of soil into old borrow pits.

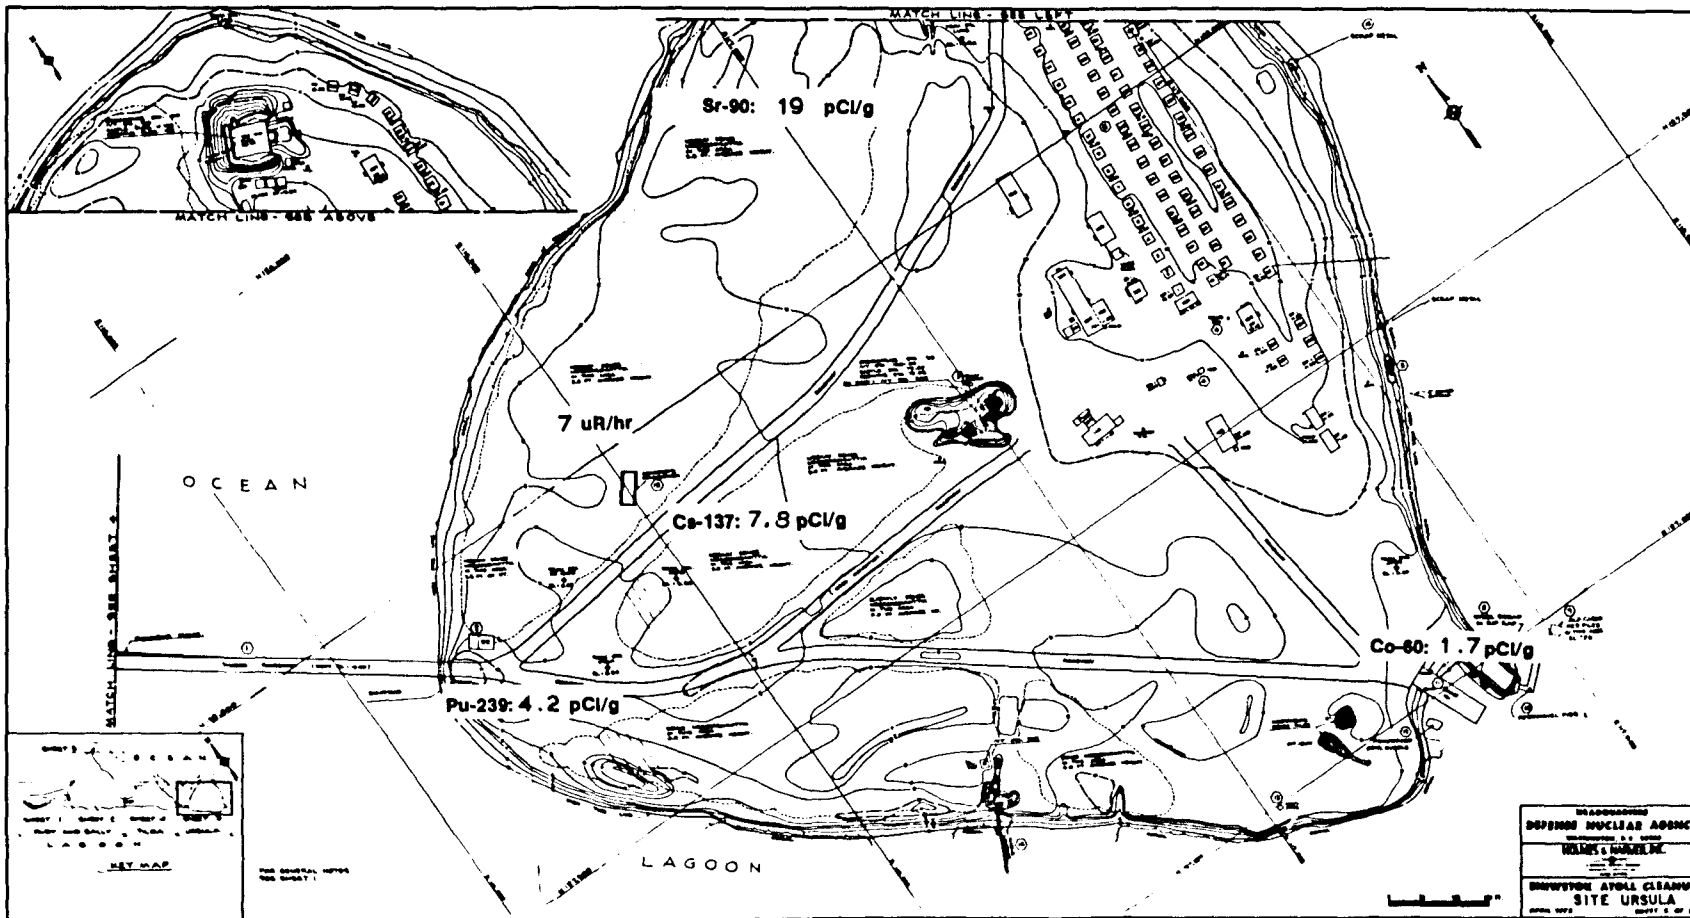
FIGURE 61. SITE URSULA

URSULA was used as the shot camp site for the AOMON-BIJIRE-LOJWA (SALLY-TILDA-URSULA) complex and much evidence of testing activities remains (Figure 61). By D+150 days of the cleanup (approx. November 15, 1977), the island will house the forward base camp for supporting cleanup teams B and C. URSULA has no surface zeroes, but received fallout from 12 events which rank it 19th in total H+1 hour exposure rate received with 651 R/h.

Although cleanup shall consist only of removing physical hazards, URSULA has received significant contamination as a result of testing. The LACROSSE EVENT on YVONNE contaminated the SALLY-URSULA complex to the extent that roads were scraped to reduce exposure of personnel in transit to work sites. The H+4 hour exposure rate on URSULA was 8 R/hr. No record of where the scraped material was disposed of is available. The MOHAWK EVENT on RUBY produced contamination which delayed recovery operations on the SALLY-URSULA complex for several days.

Some decontamination facilities will be operated on URSULA in support of cleanup operations.

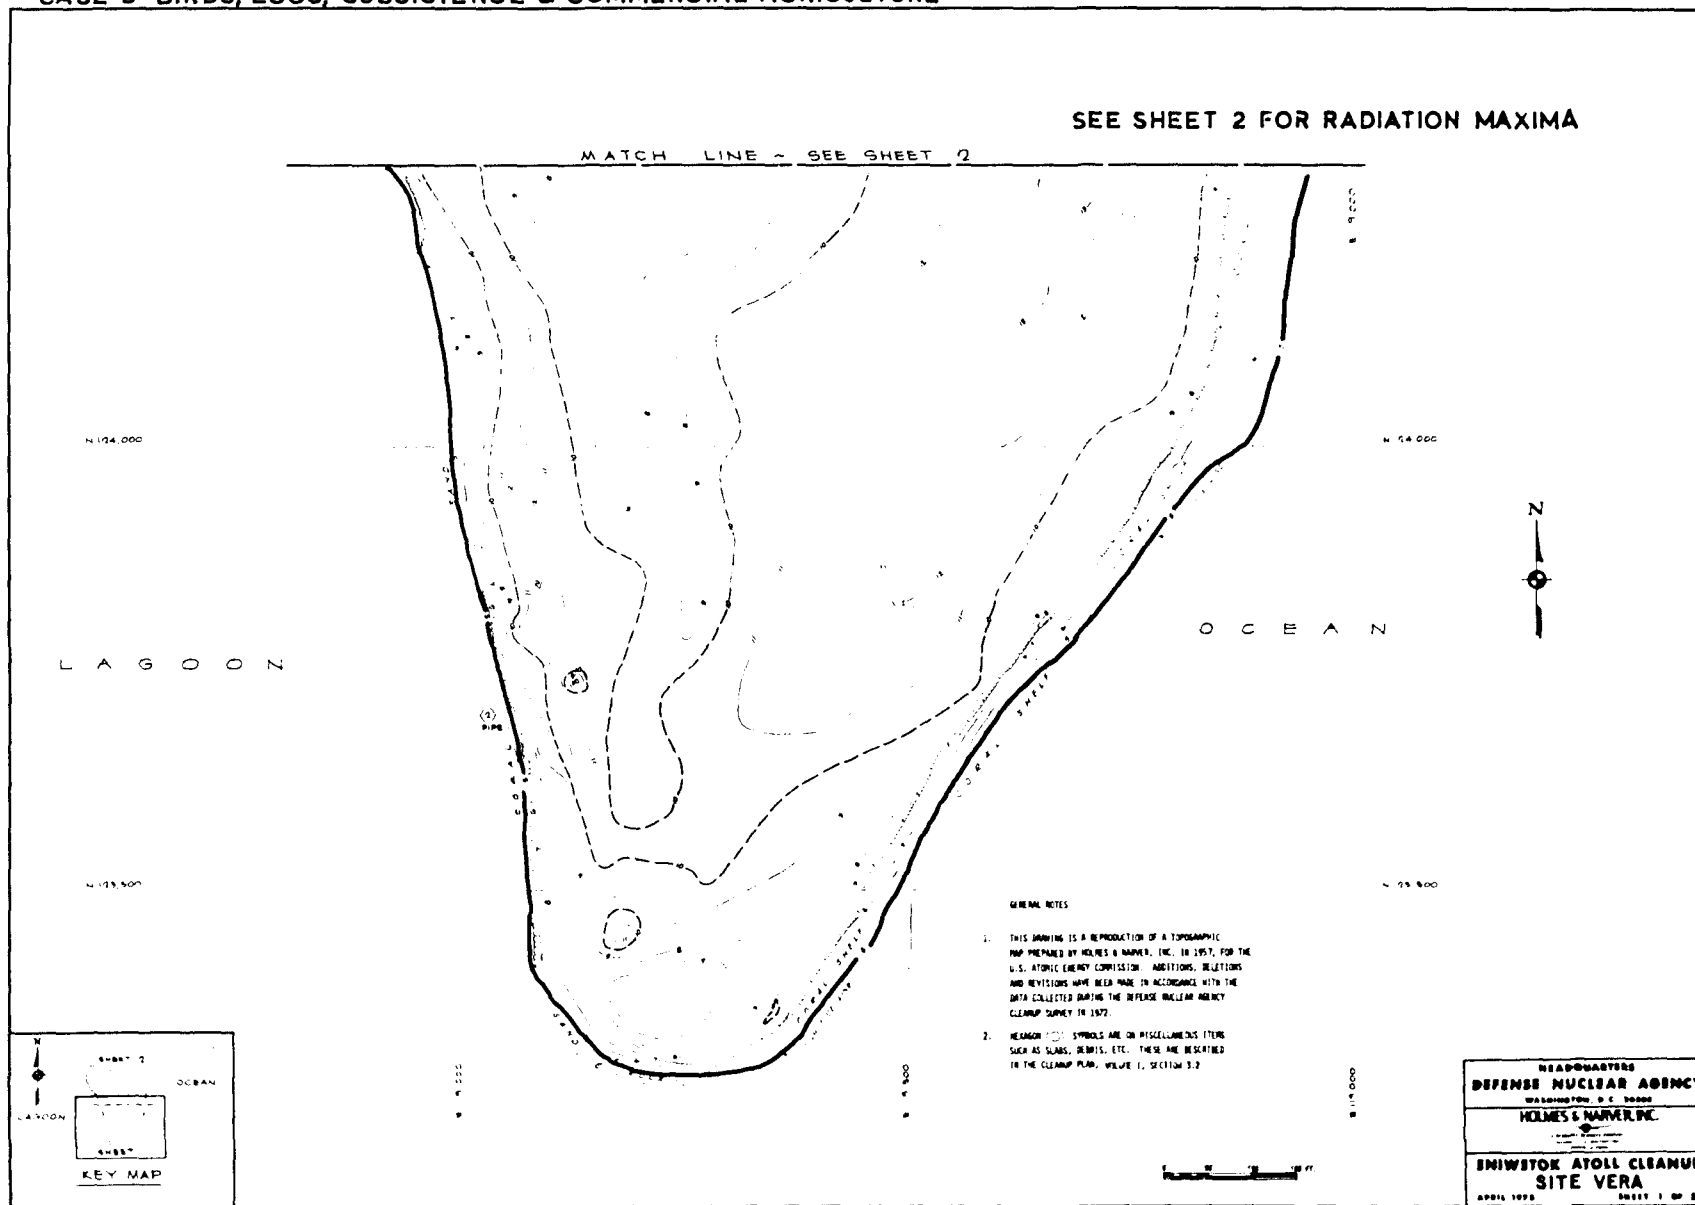
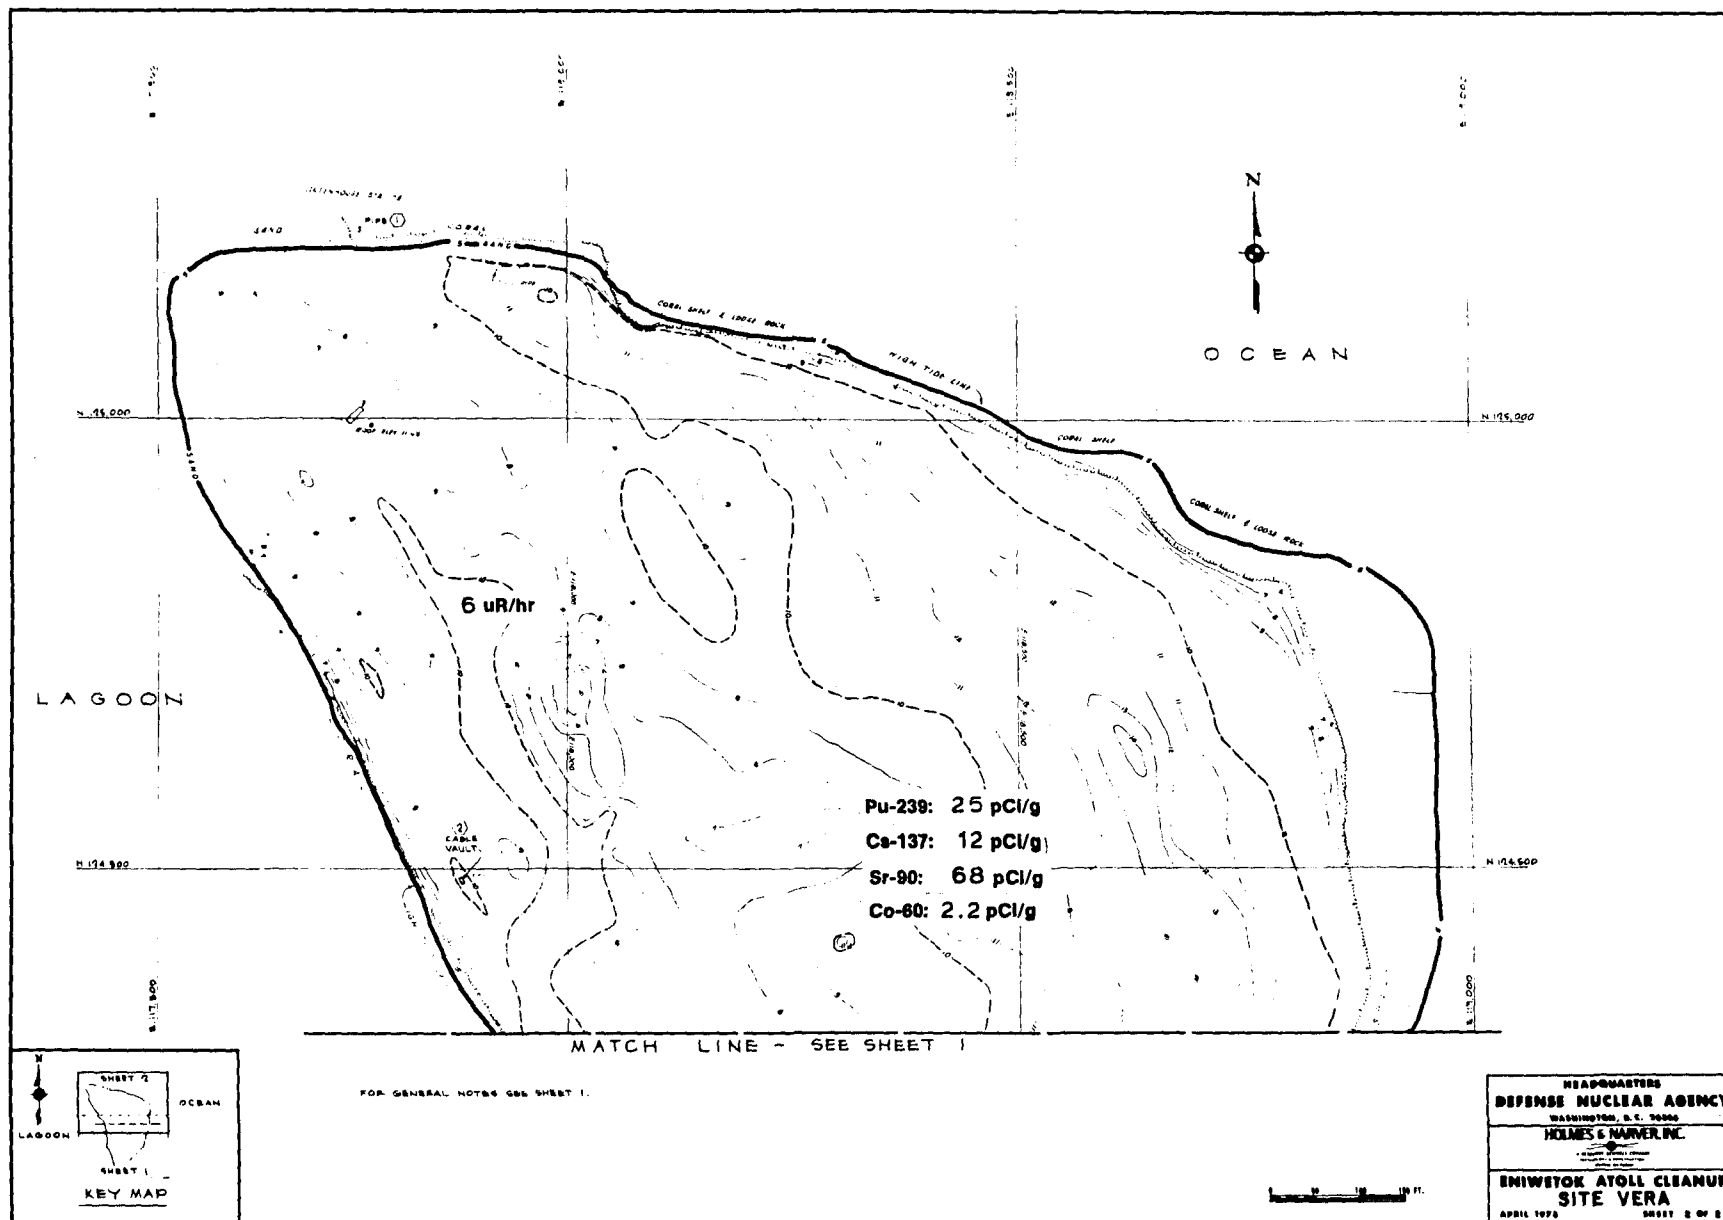
VERA is located in the northeast portion of Enewetak Atoll and has an area of about 38 acres (15 hectares). The island, densely vegetated, is outlined in Figures 62 and 63.

A small amount of debris remains from testing. A scientific station which housed animals for medical research during OPERATION GREENHOUSE remains and is in poor condition. VERA has no surface zeroes and ranks 22nd of all islands in the Atoll with 270 R/h accumulated H+1 hour exposure rate.

The highest ^{239}Pu values found were 35 pCi/g in thin layers from profile sampling. The depth distributions of activity in soil show relaxation lengths of 2-5 cm near the northwest beach to 10-15 cm in the island's interior.

No radioactive material burial sites are known to exist on VERA.

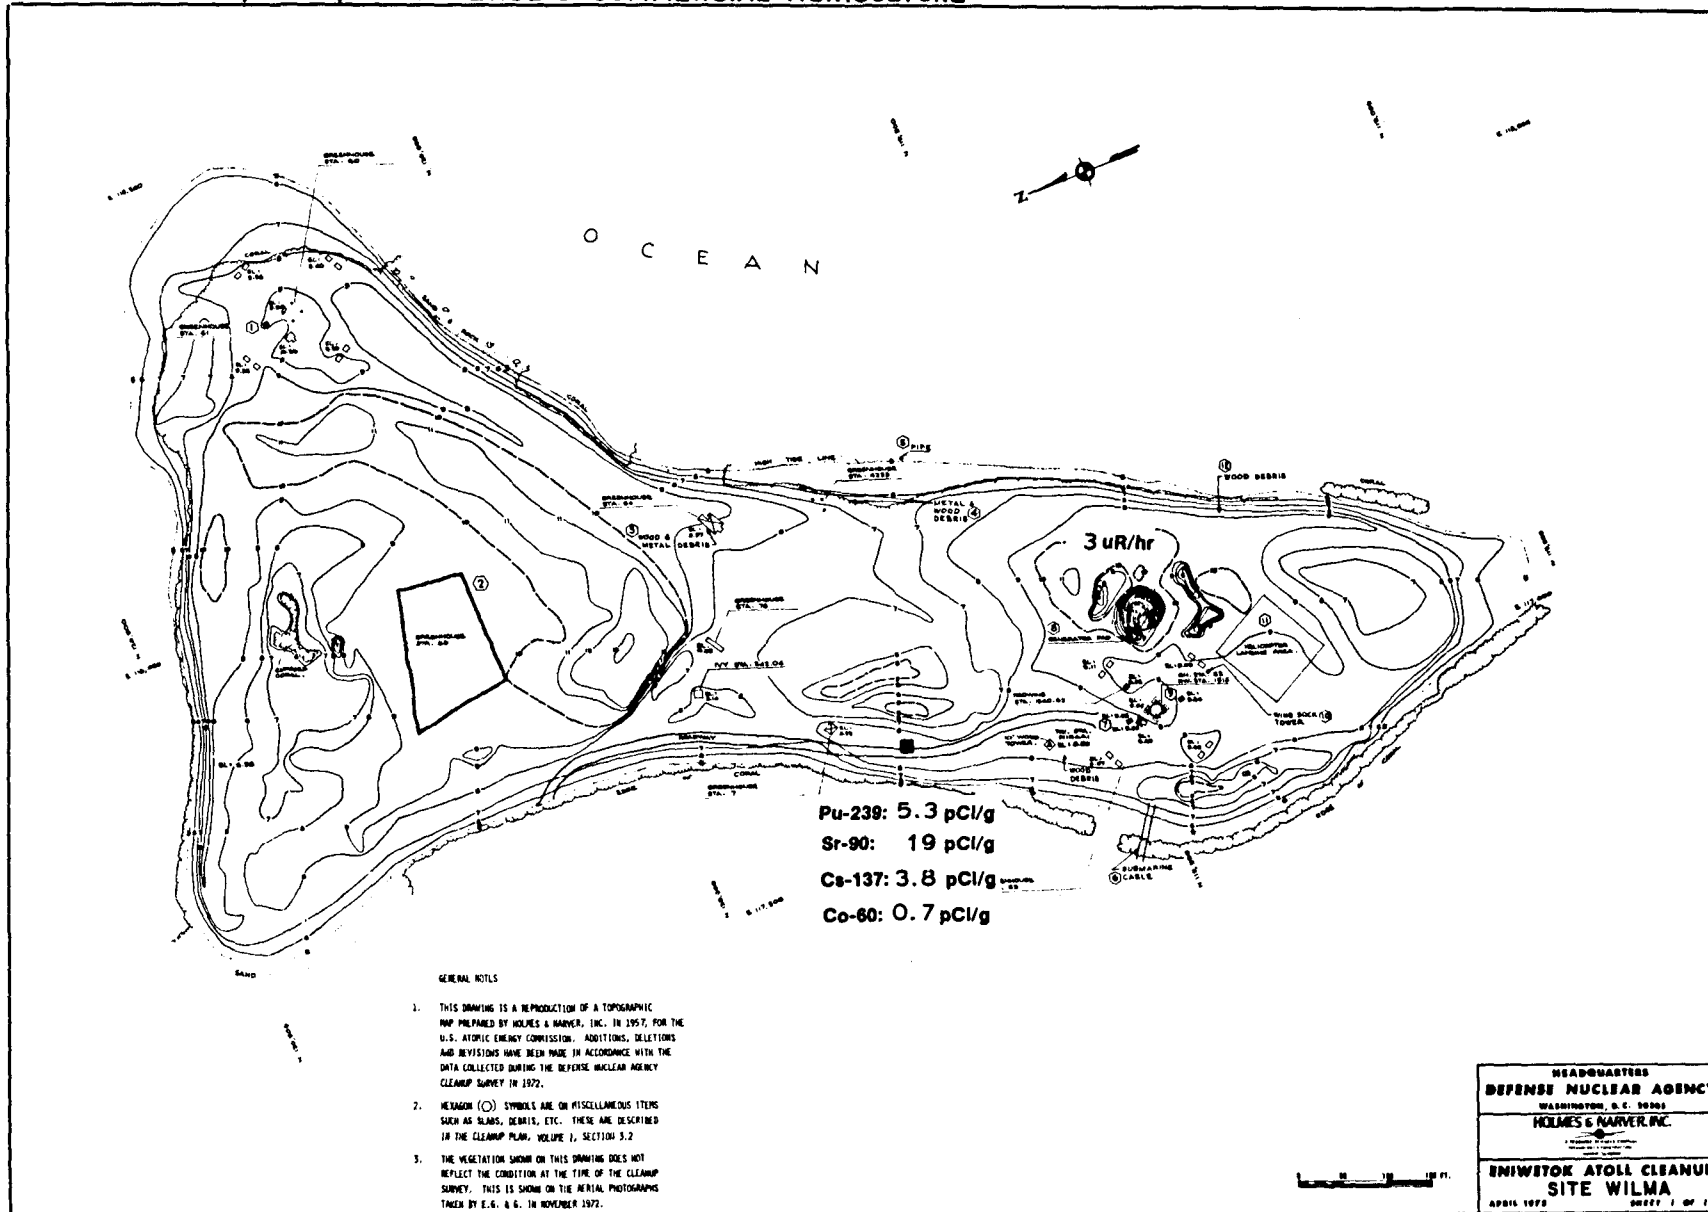
FIGURE 64. SITE WILMA

Eight scientific stations with a moderate amount of debris remain on WILMA (Figure 64). WILMA has no surface zeroes and ranks 21st among islands of the Atoll with 294 R/h accumulated H+1 hour exposure rate.

No radioactive material burial sites are known to exist on WILMA.
